Debris/Ice/TPS Assessment And Photographic Analysis For Shuttle Mission STS-31R

Charles G. Stevenson
NASA/Kennedy Space Center

DEBRIS/ICE/TPS ASSESSMENT
AND
PHOTOGRAPHIC ANALYSIS
OF
SHUTTLE MISSION STS-31R

April 24, 1990

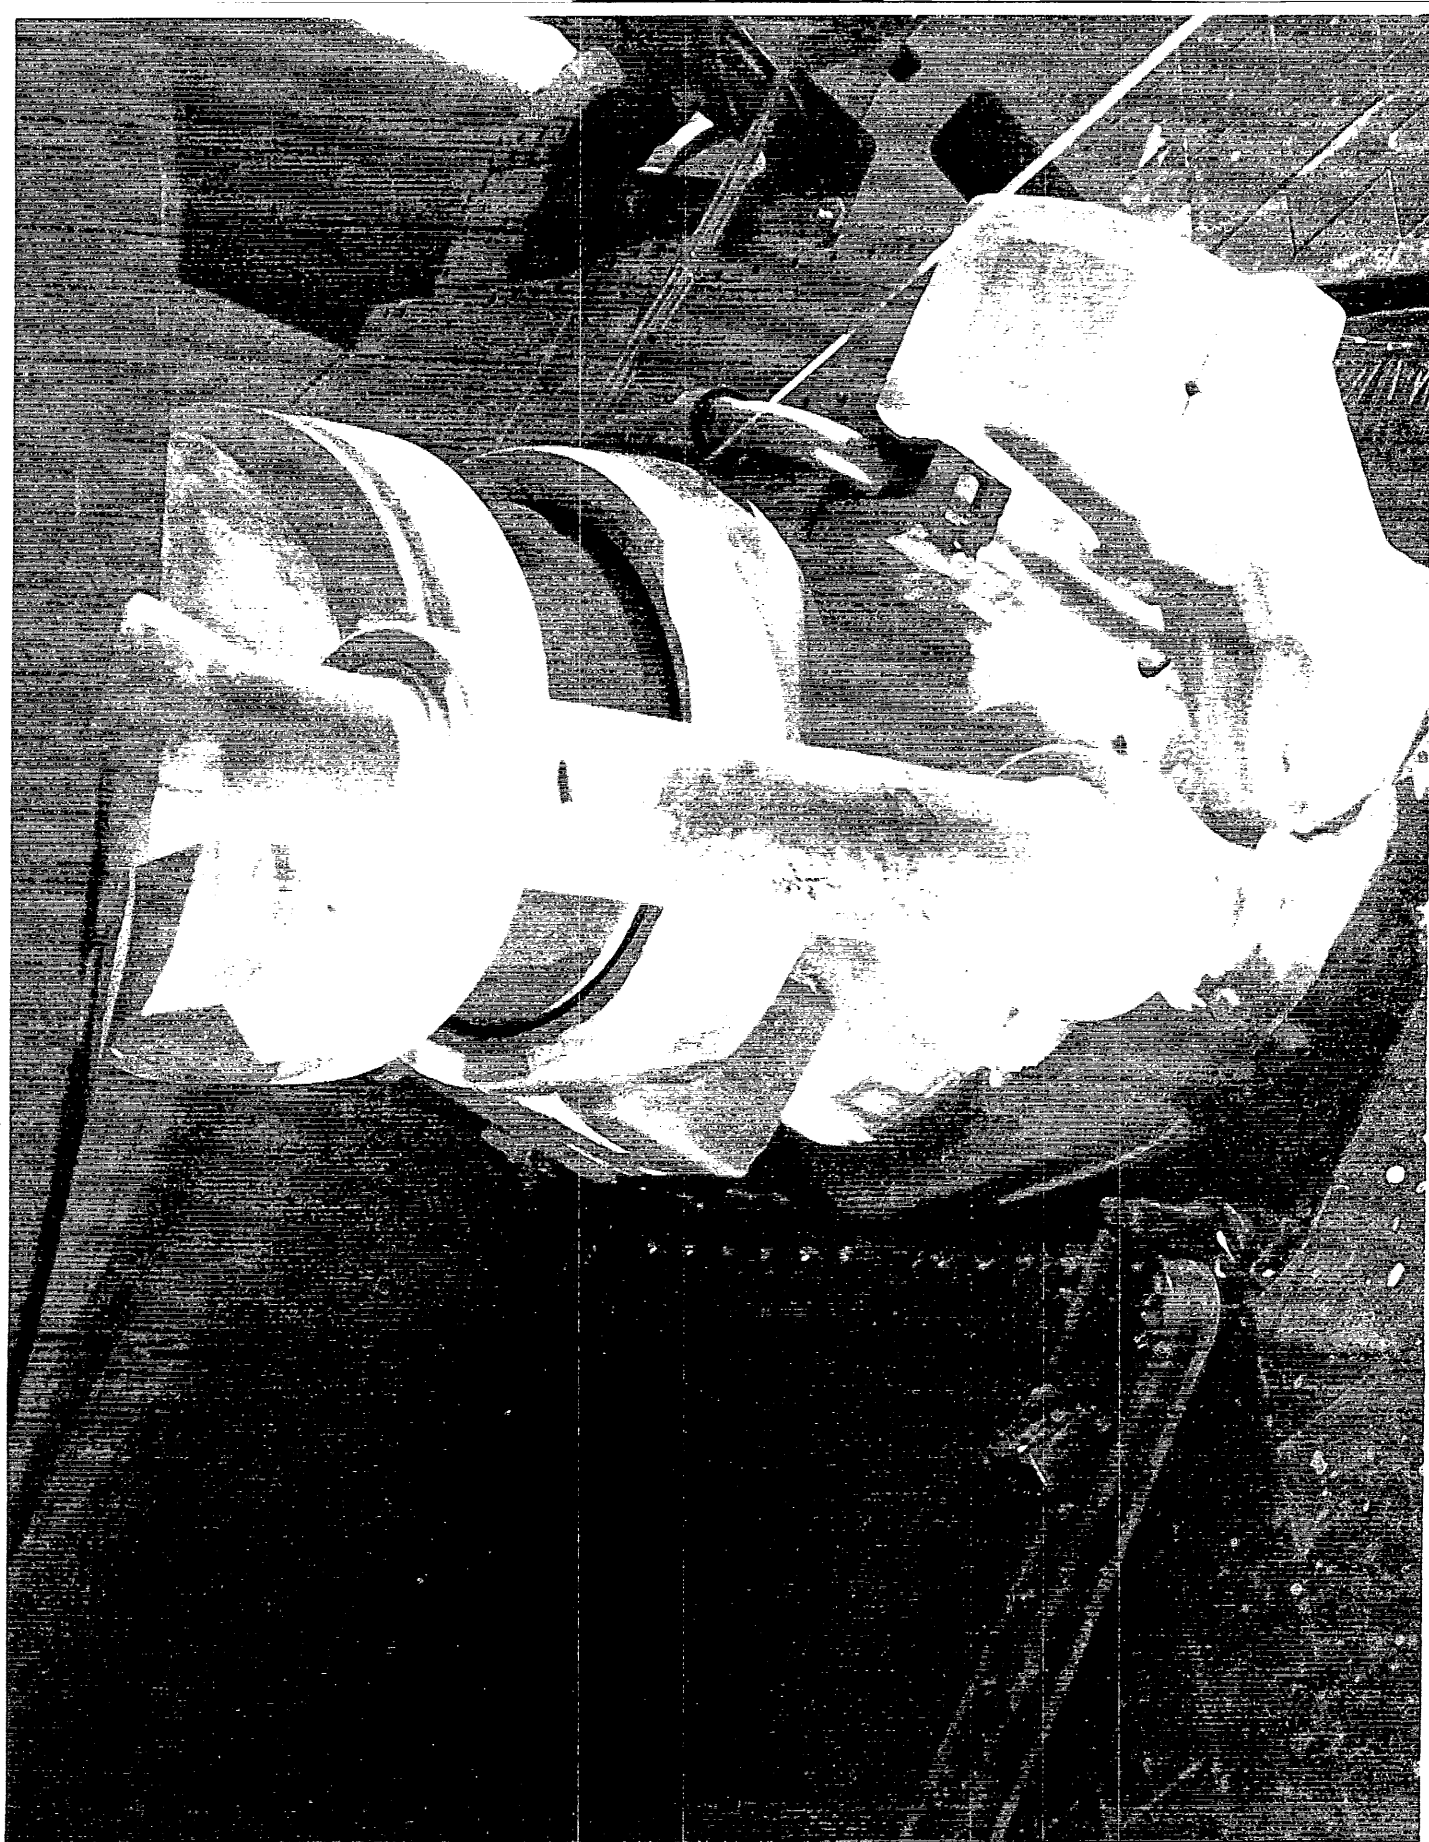
Normal amounts of ice/frost had formed in the LH2 recirculation line bellows. No ice was present in the LH2 feedline bellows.

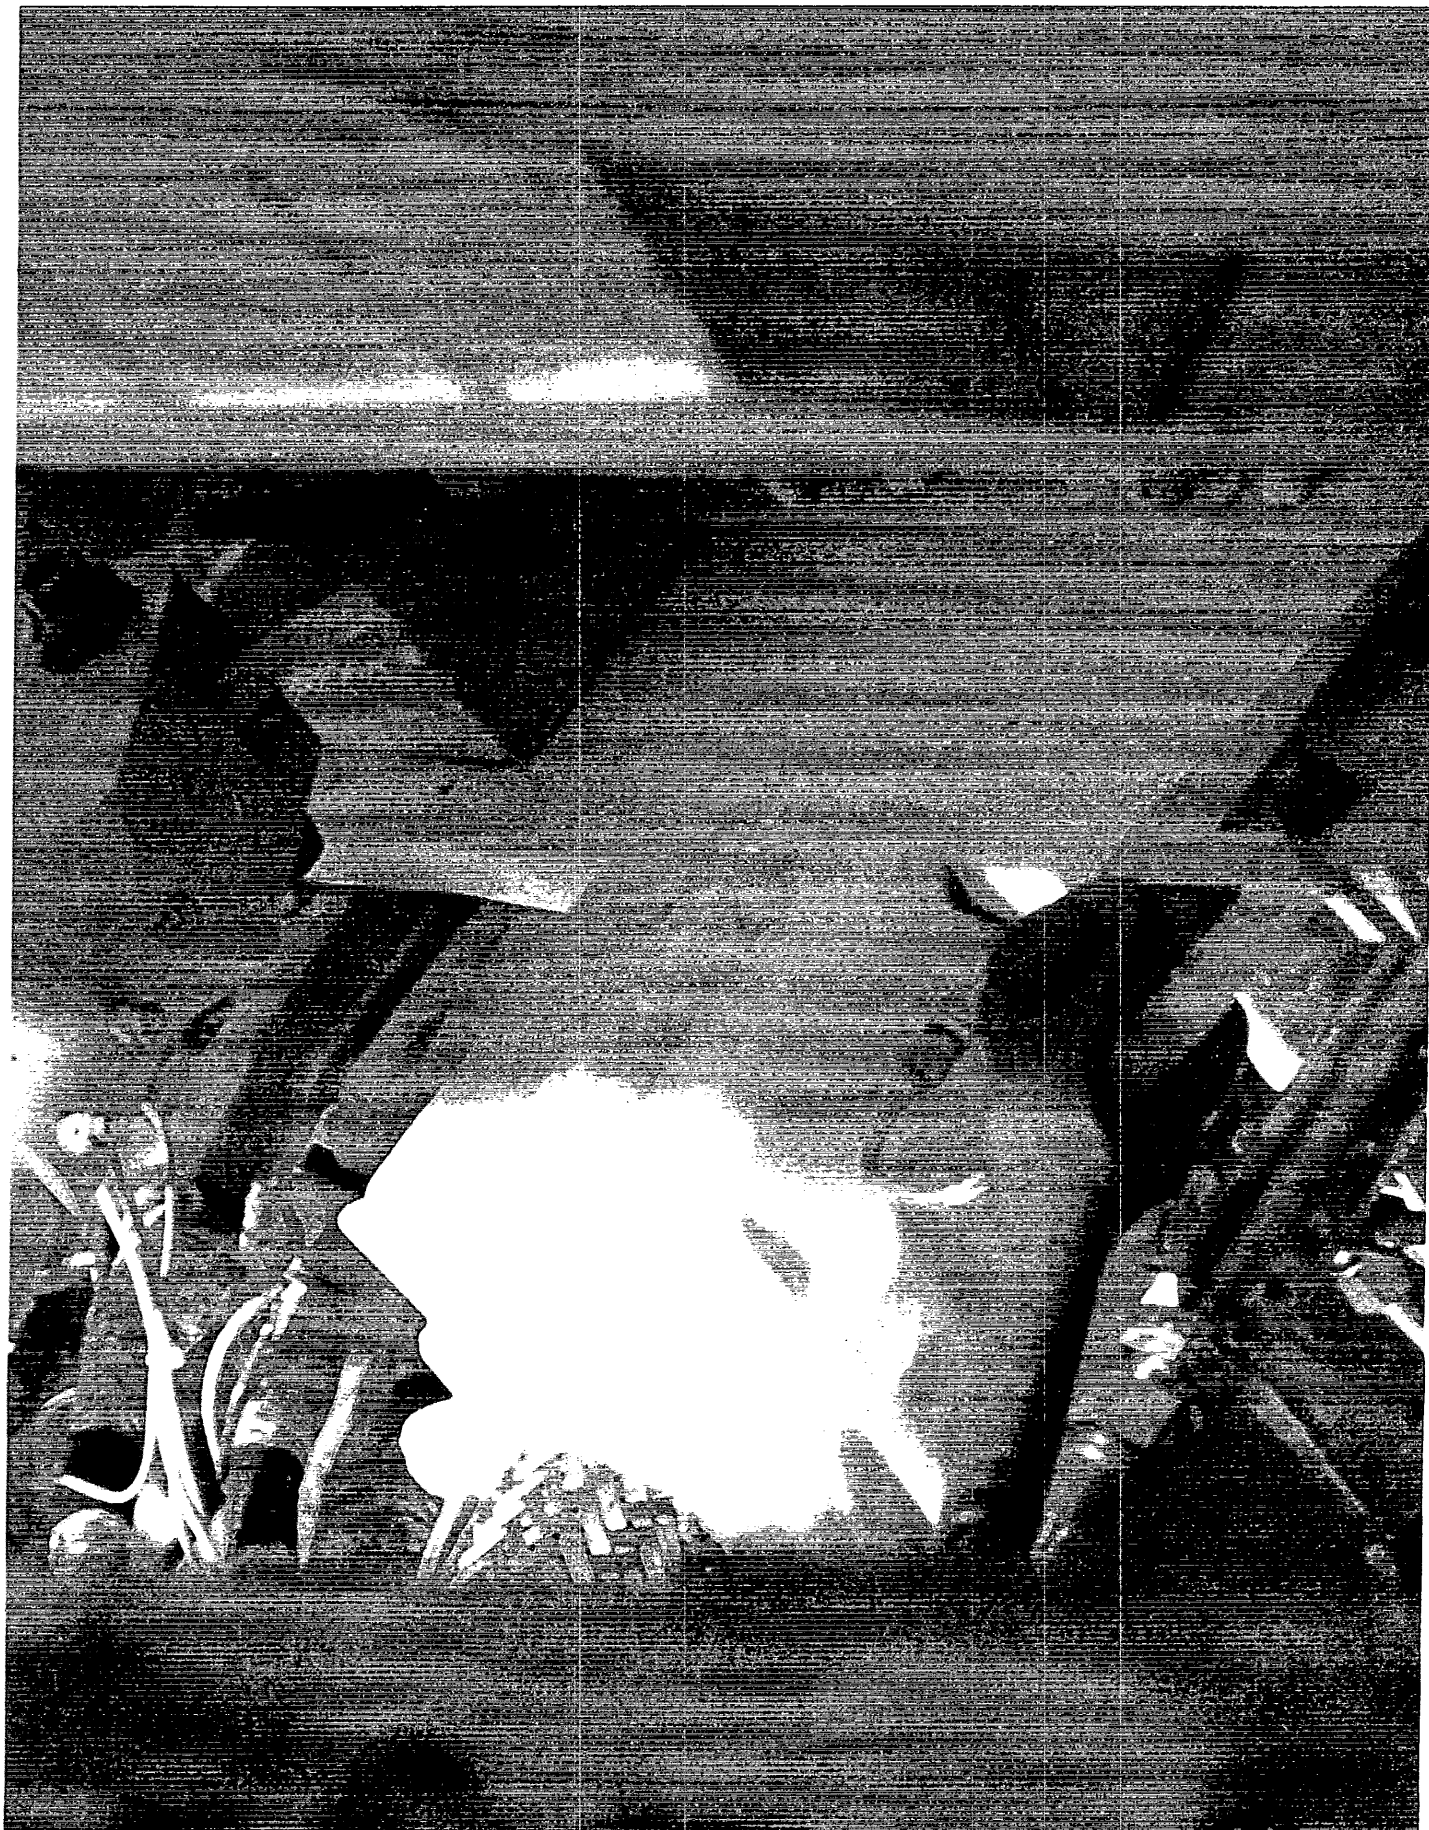
Ice/frost typically covers the 1-1/2 inch high point bleed QD
purge shroud

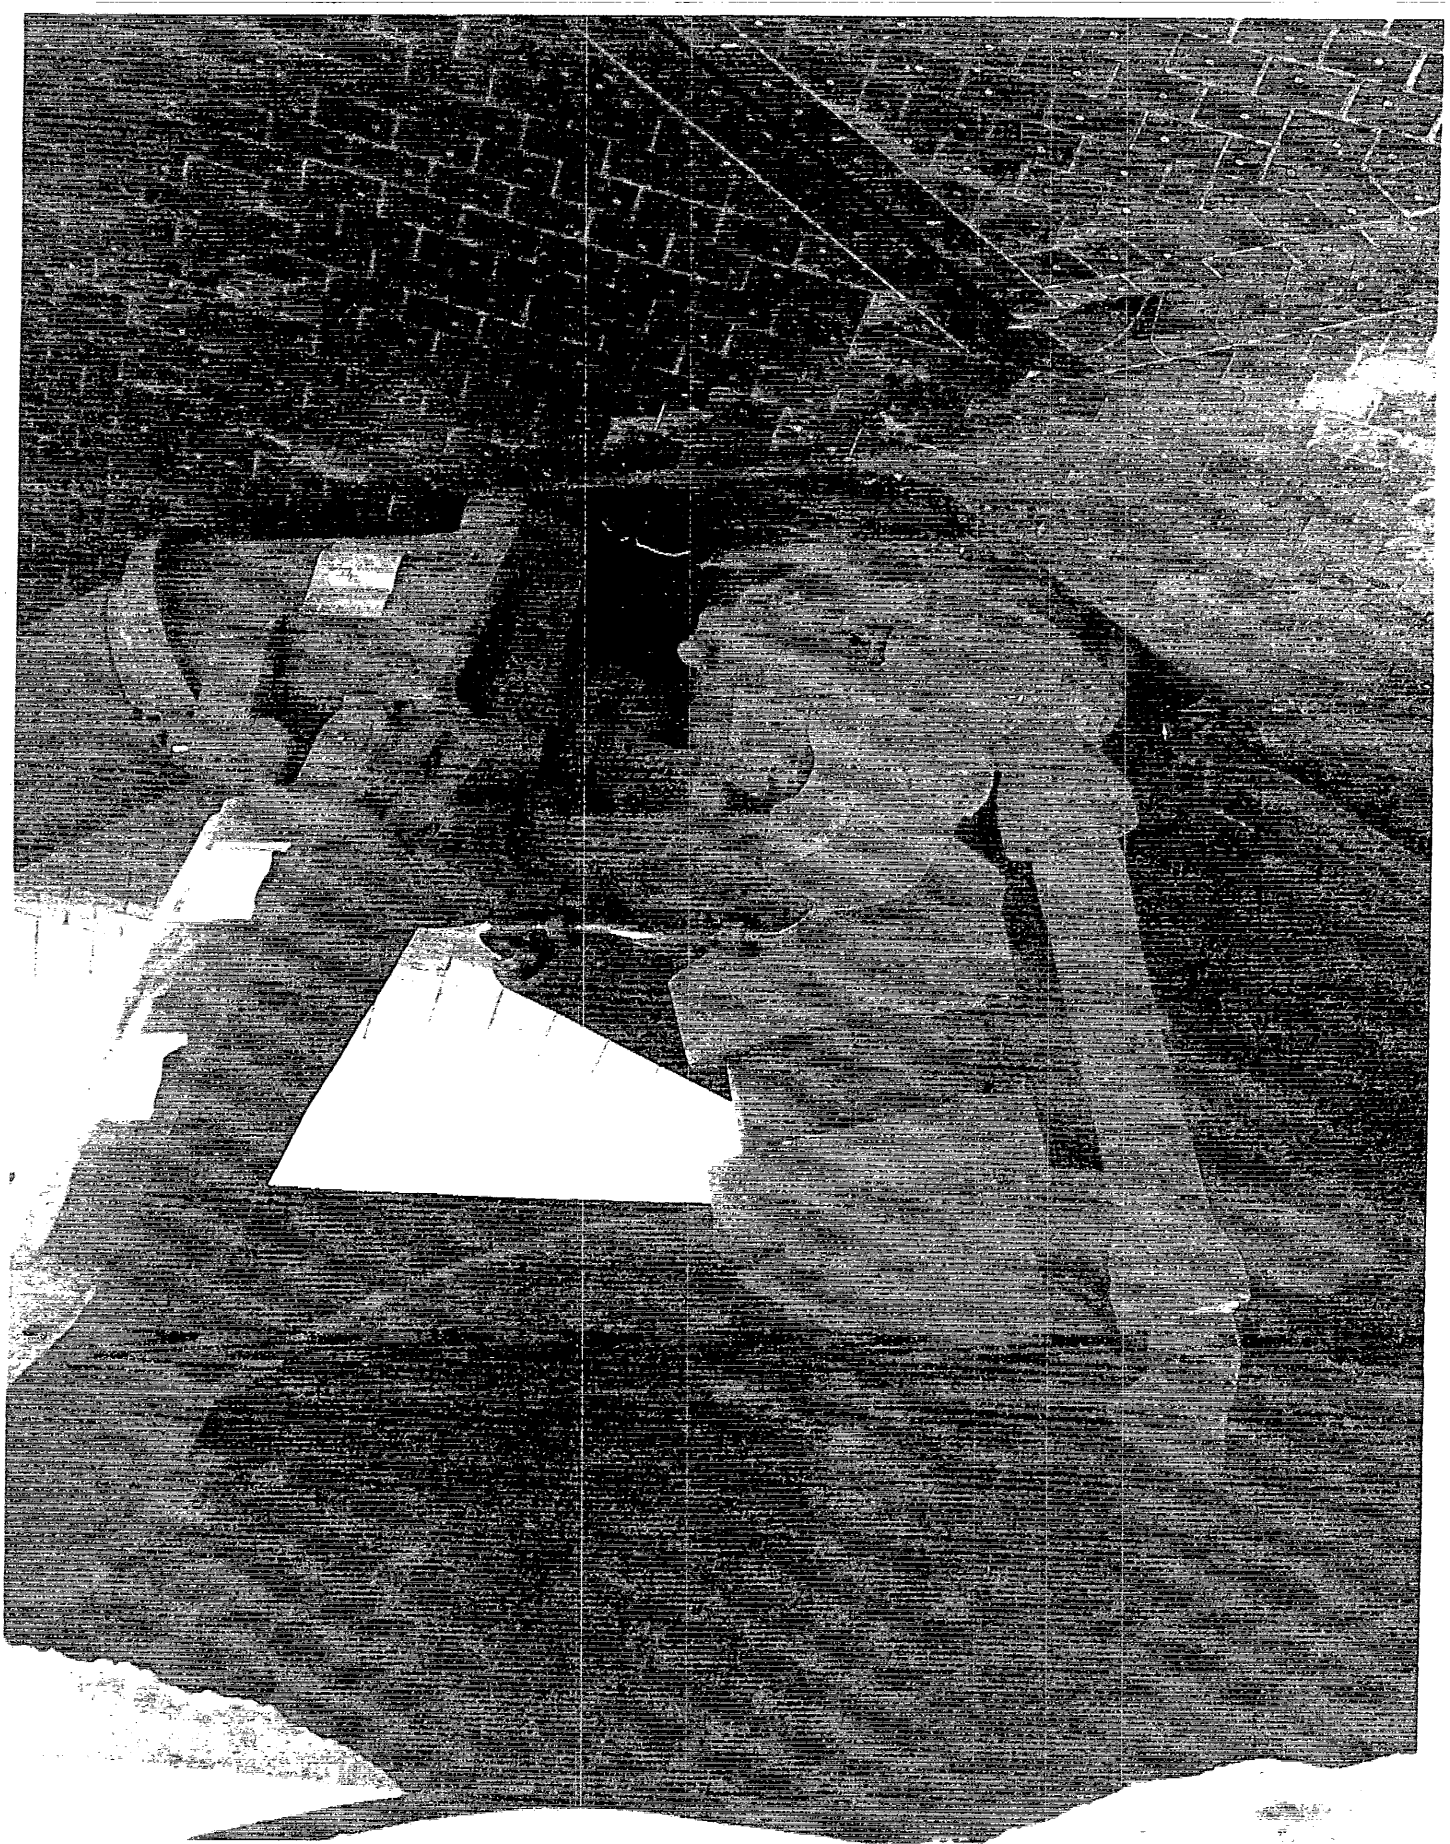
Hard ice is still present on the LH2 umbilical outboard side,
purge vents, feedline and recirc line bellows after ET drain

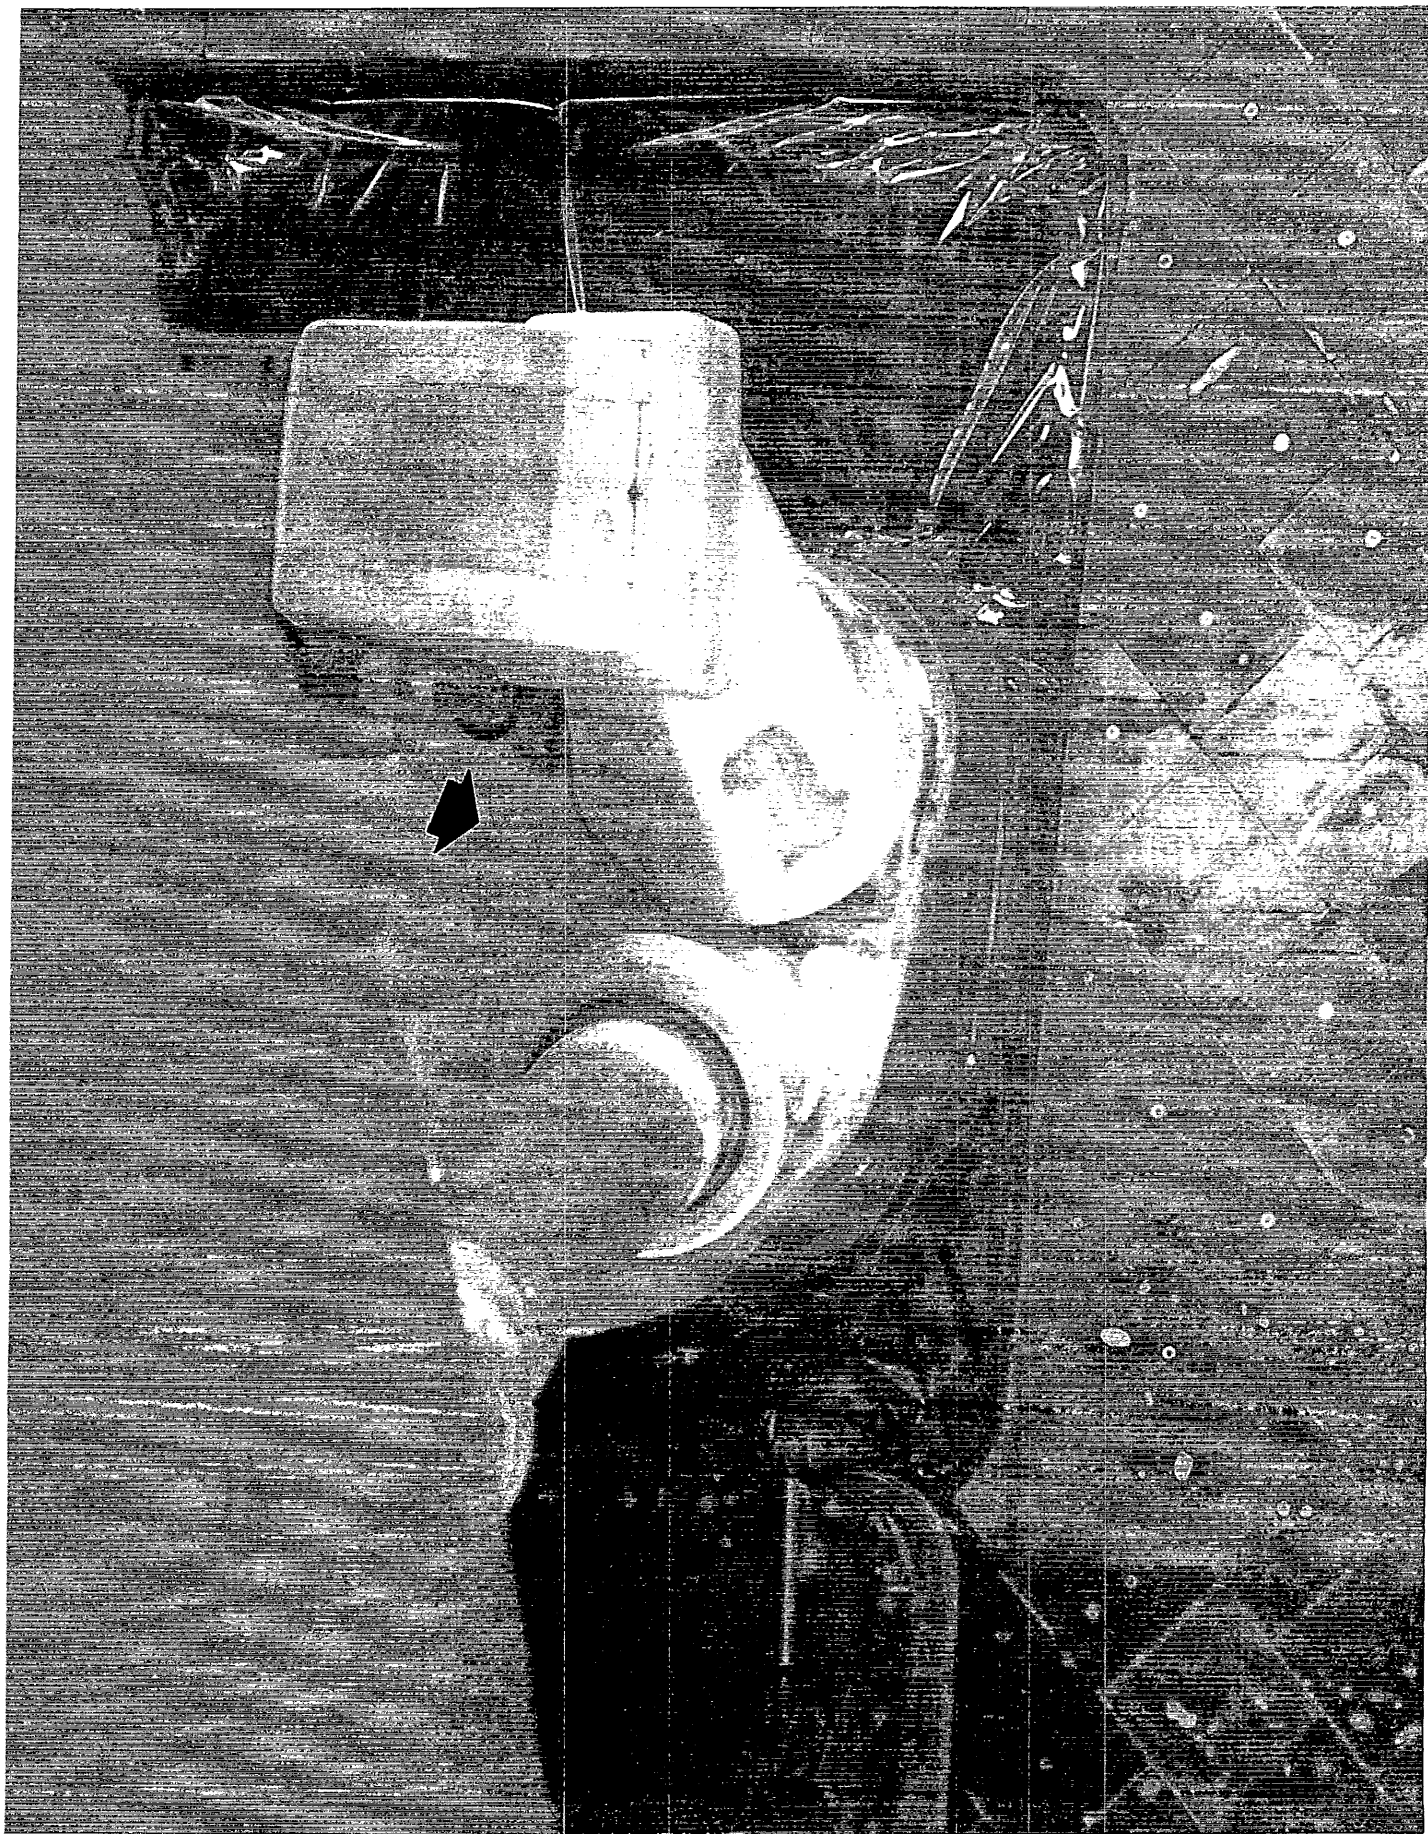
The PDL foam plug in the flapper valve actuator torque tool port closeout shows no anomalies after the first cryo-load

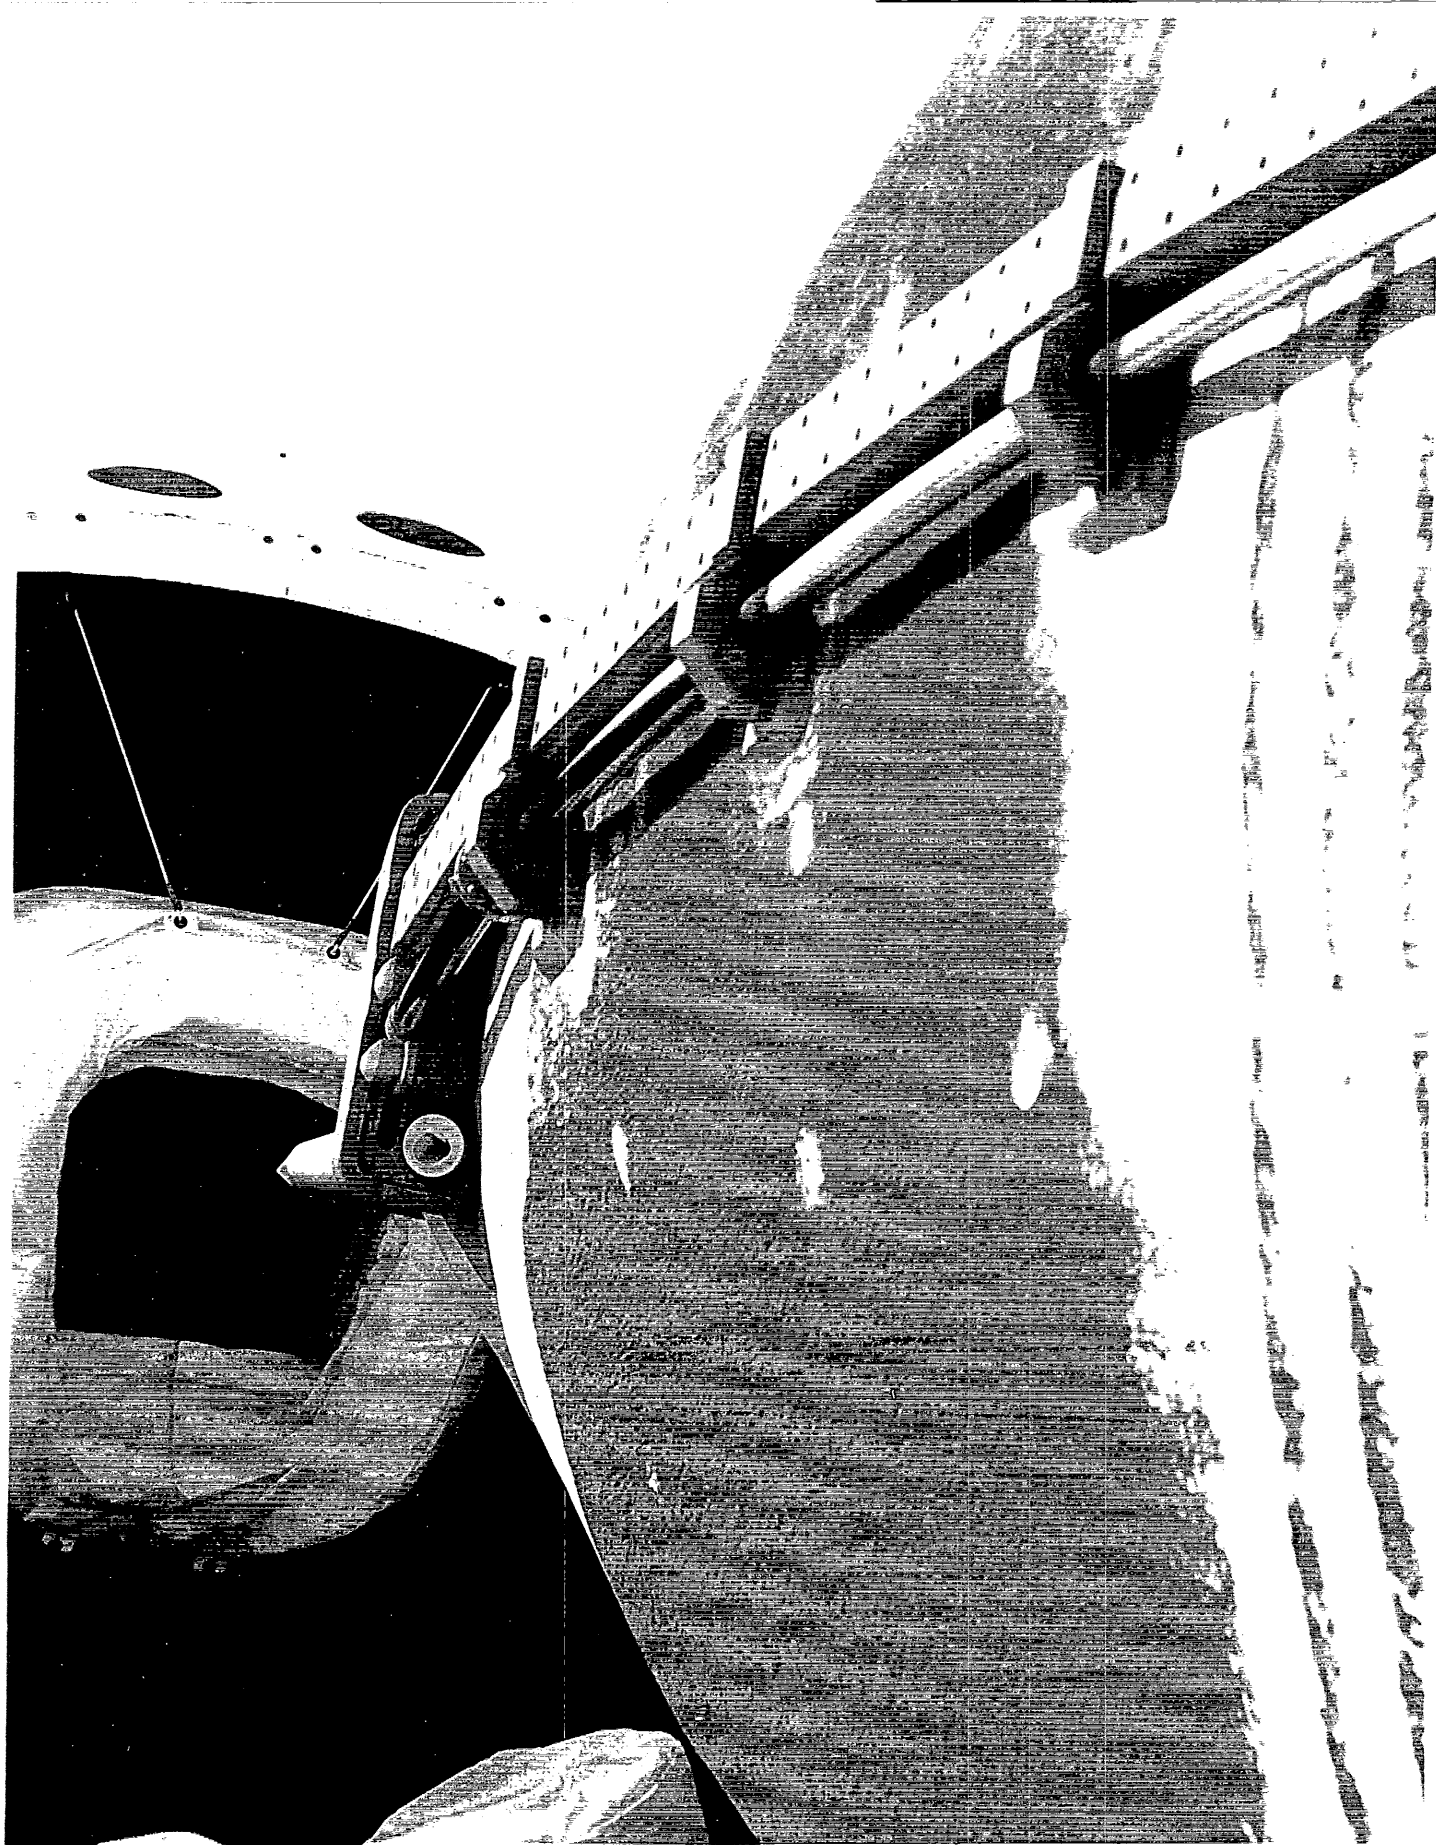
Prelaunch condition of ET tumble valve cover

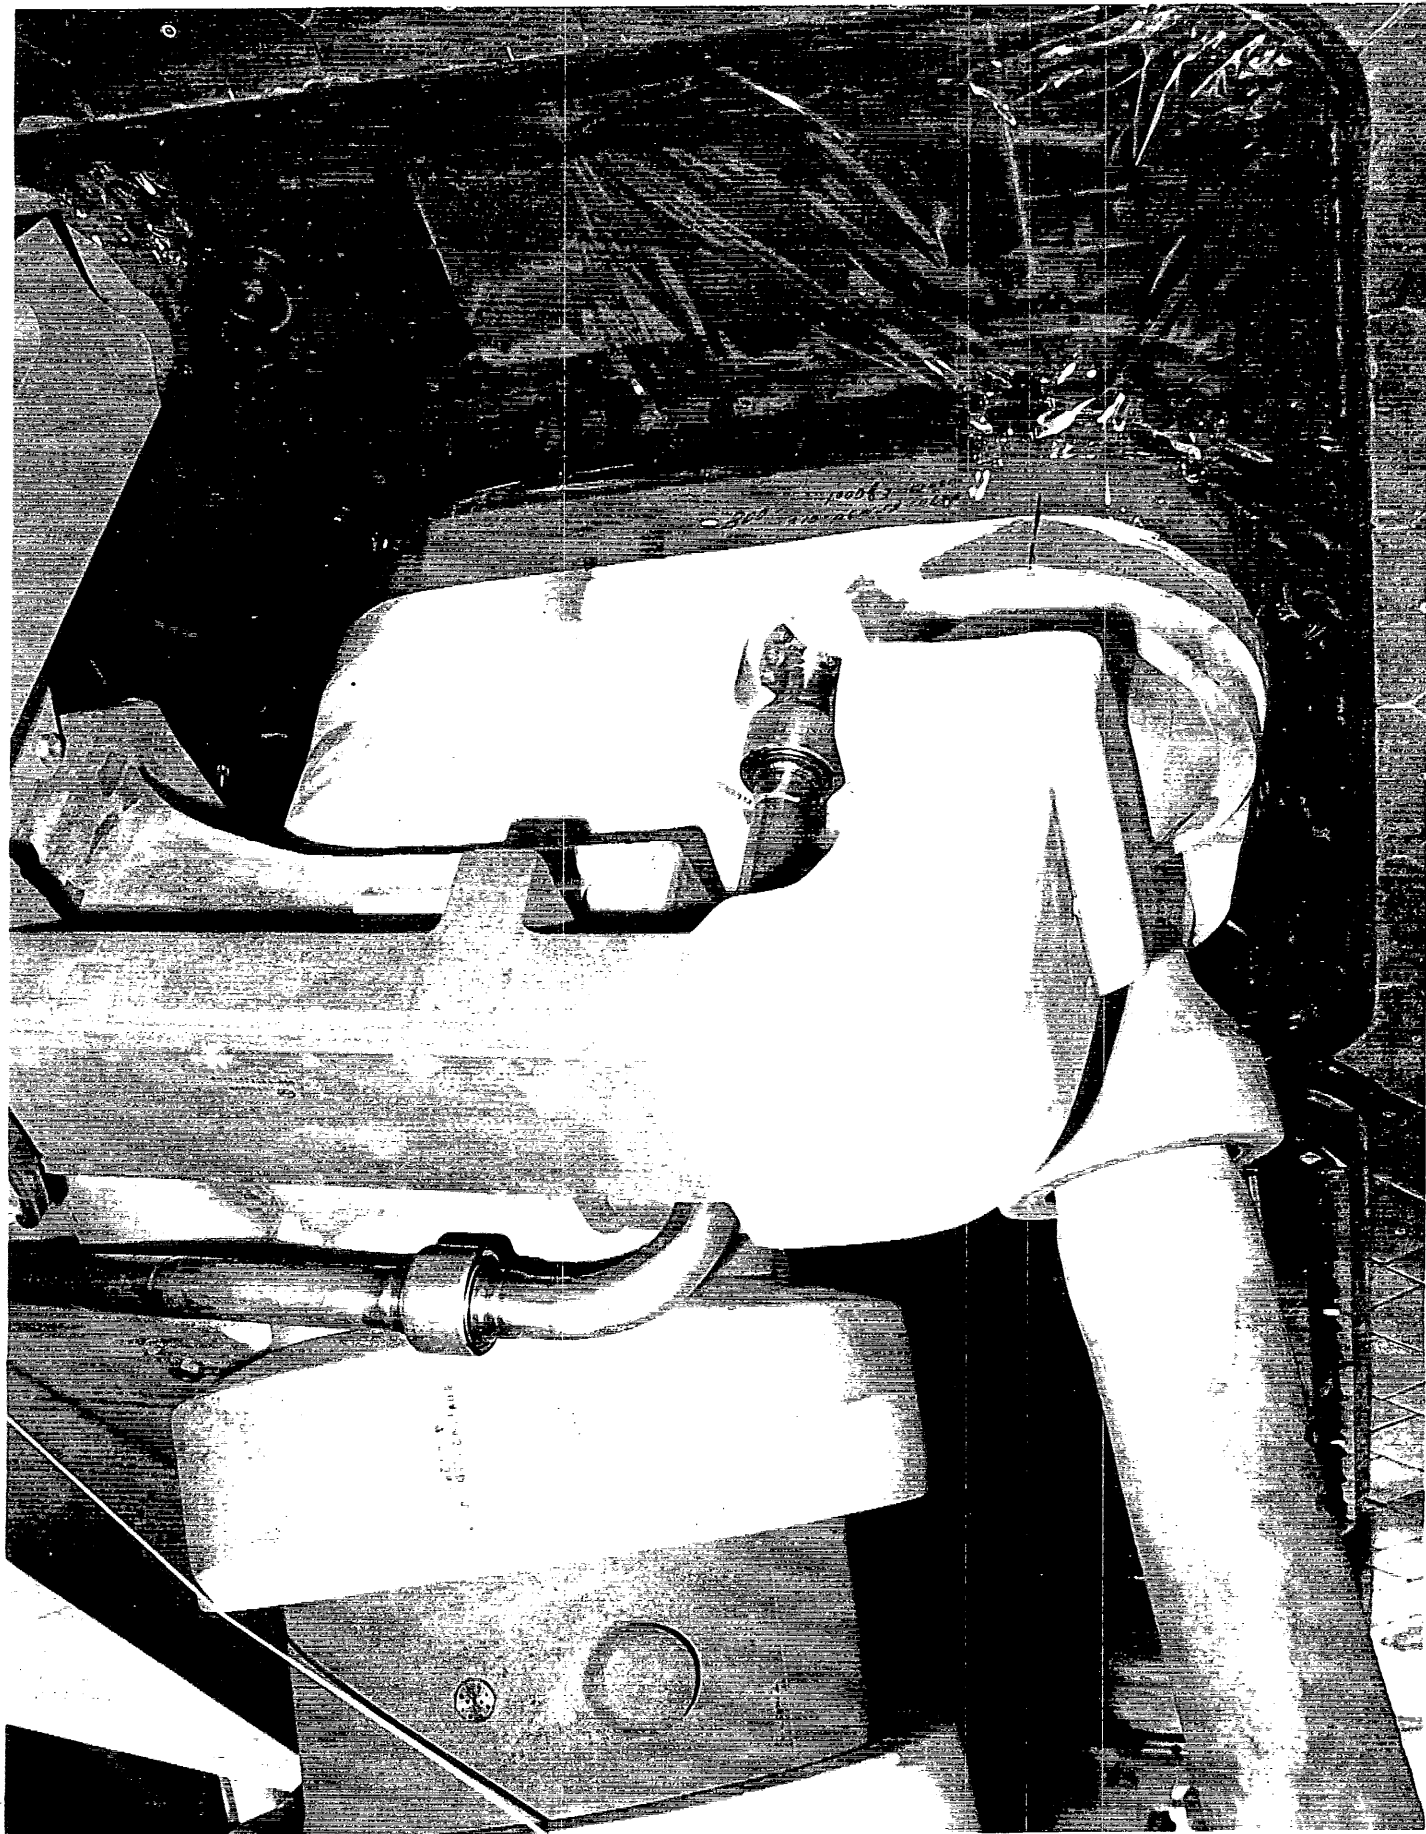
LH2 ET/ORB umbilical prior to second cryo-load. Cord in upper left corner is attached to hydrogen detection system tygon tube

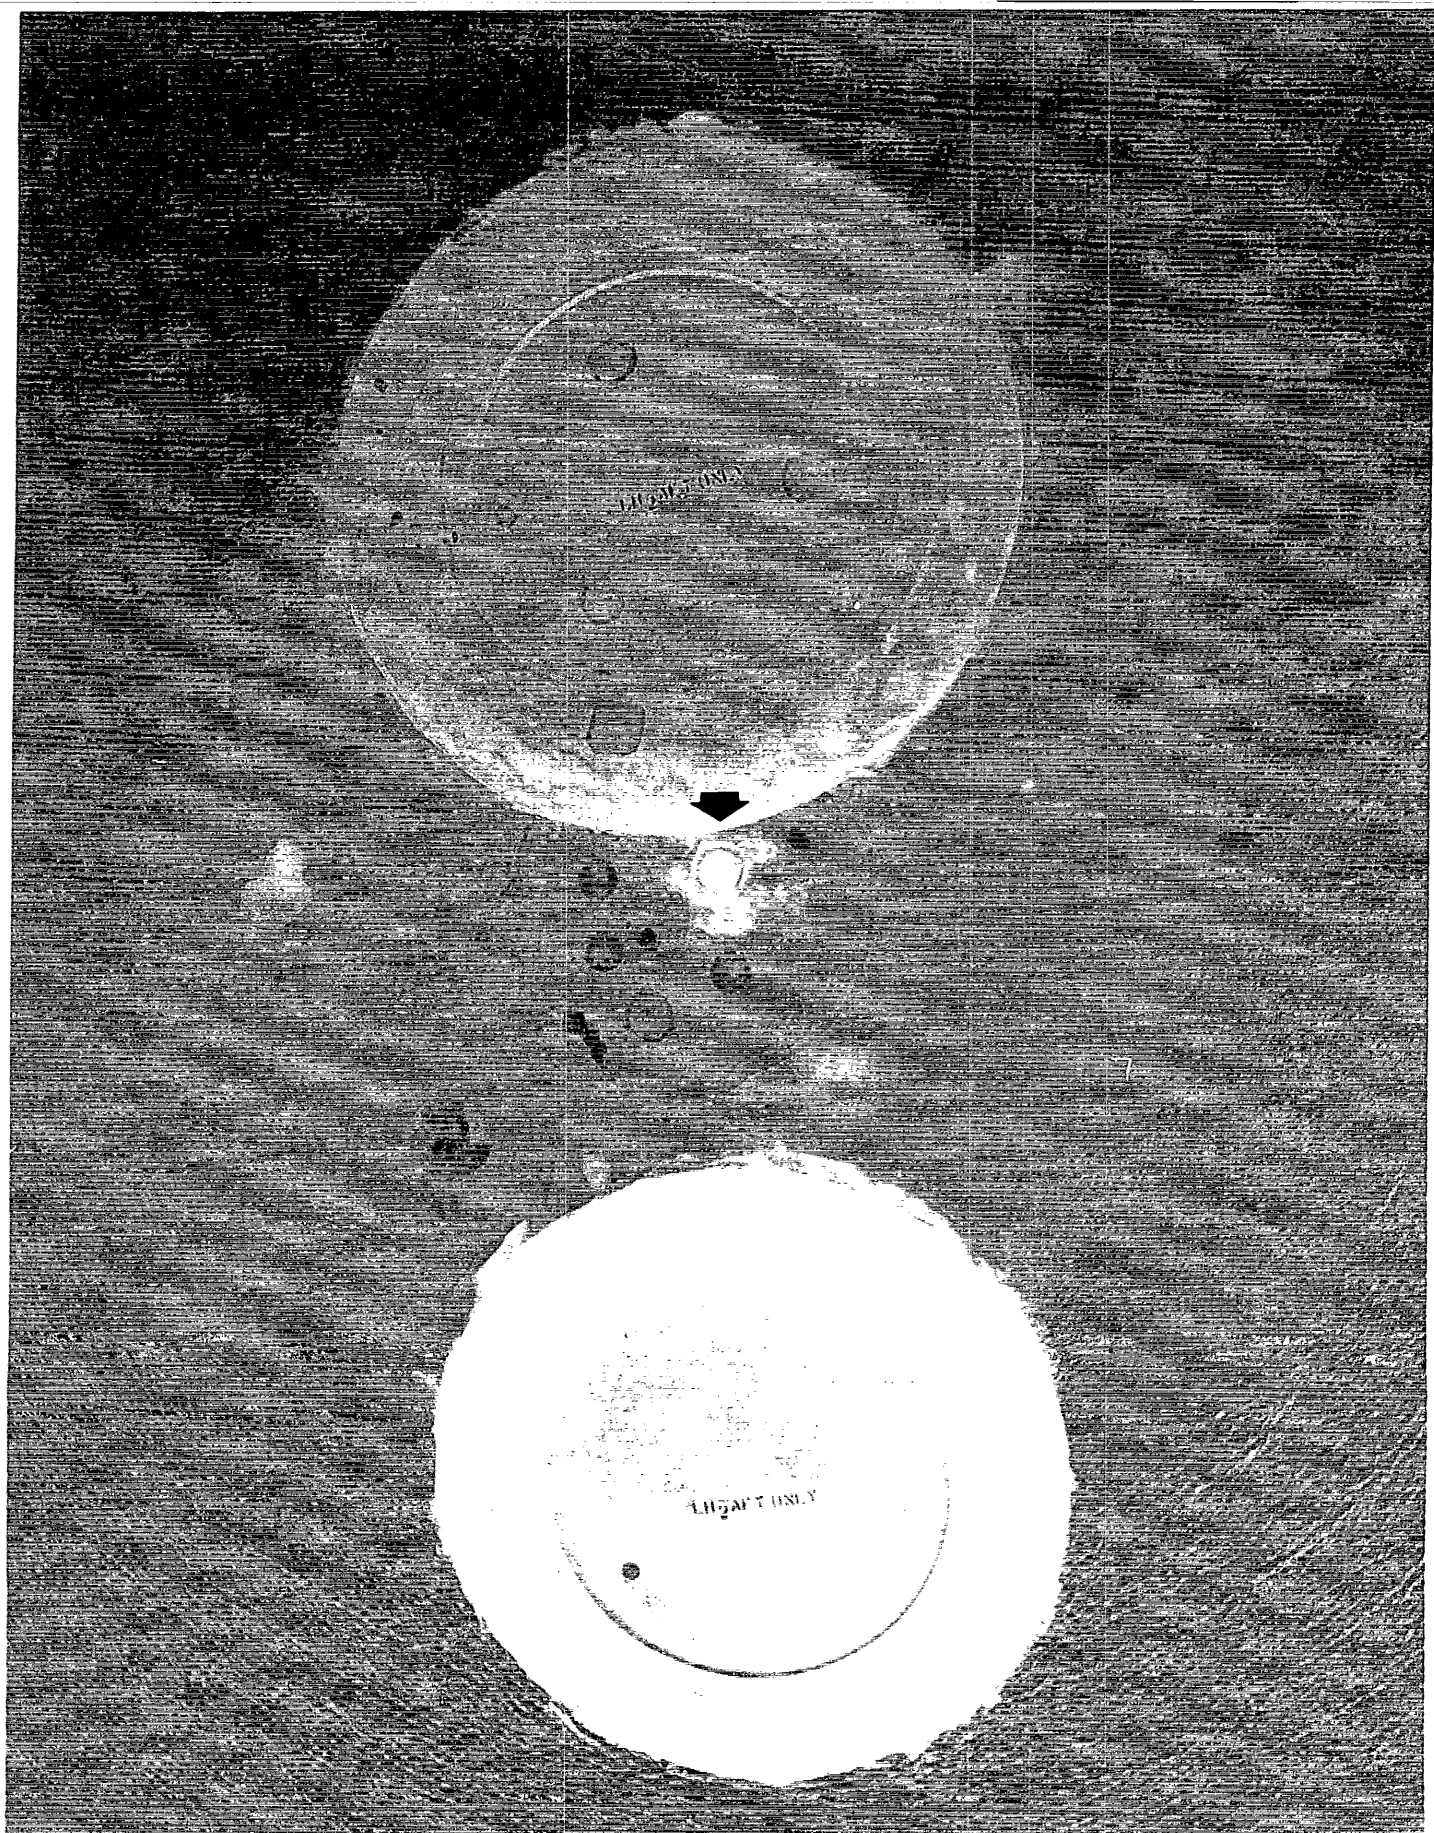
During the reinstallation of the hydrogen detection system tygon tubing for the second launch attempt, a 3-inch diameter foam repair in the LH2 tank aft dome apex was discovered to be missing. This condition was repaired per PR ET-34-TS-0044 prior to launch.

3-inch diameter repair on the ET aft dome apex fell out after drain and was repaired prior to the second cryo-load

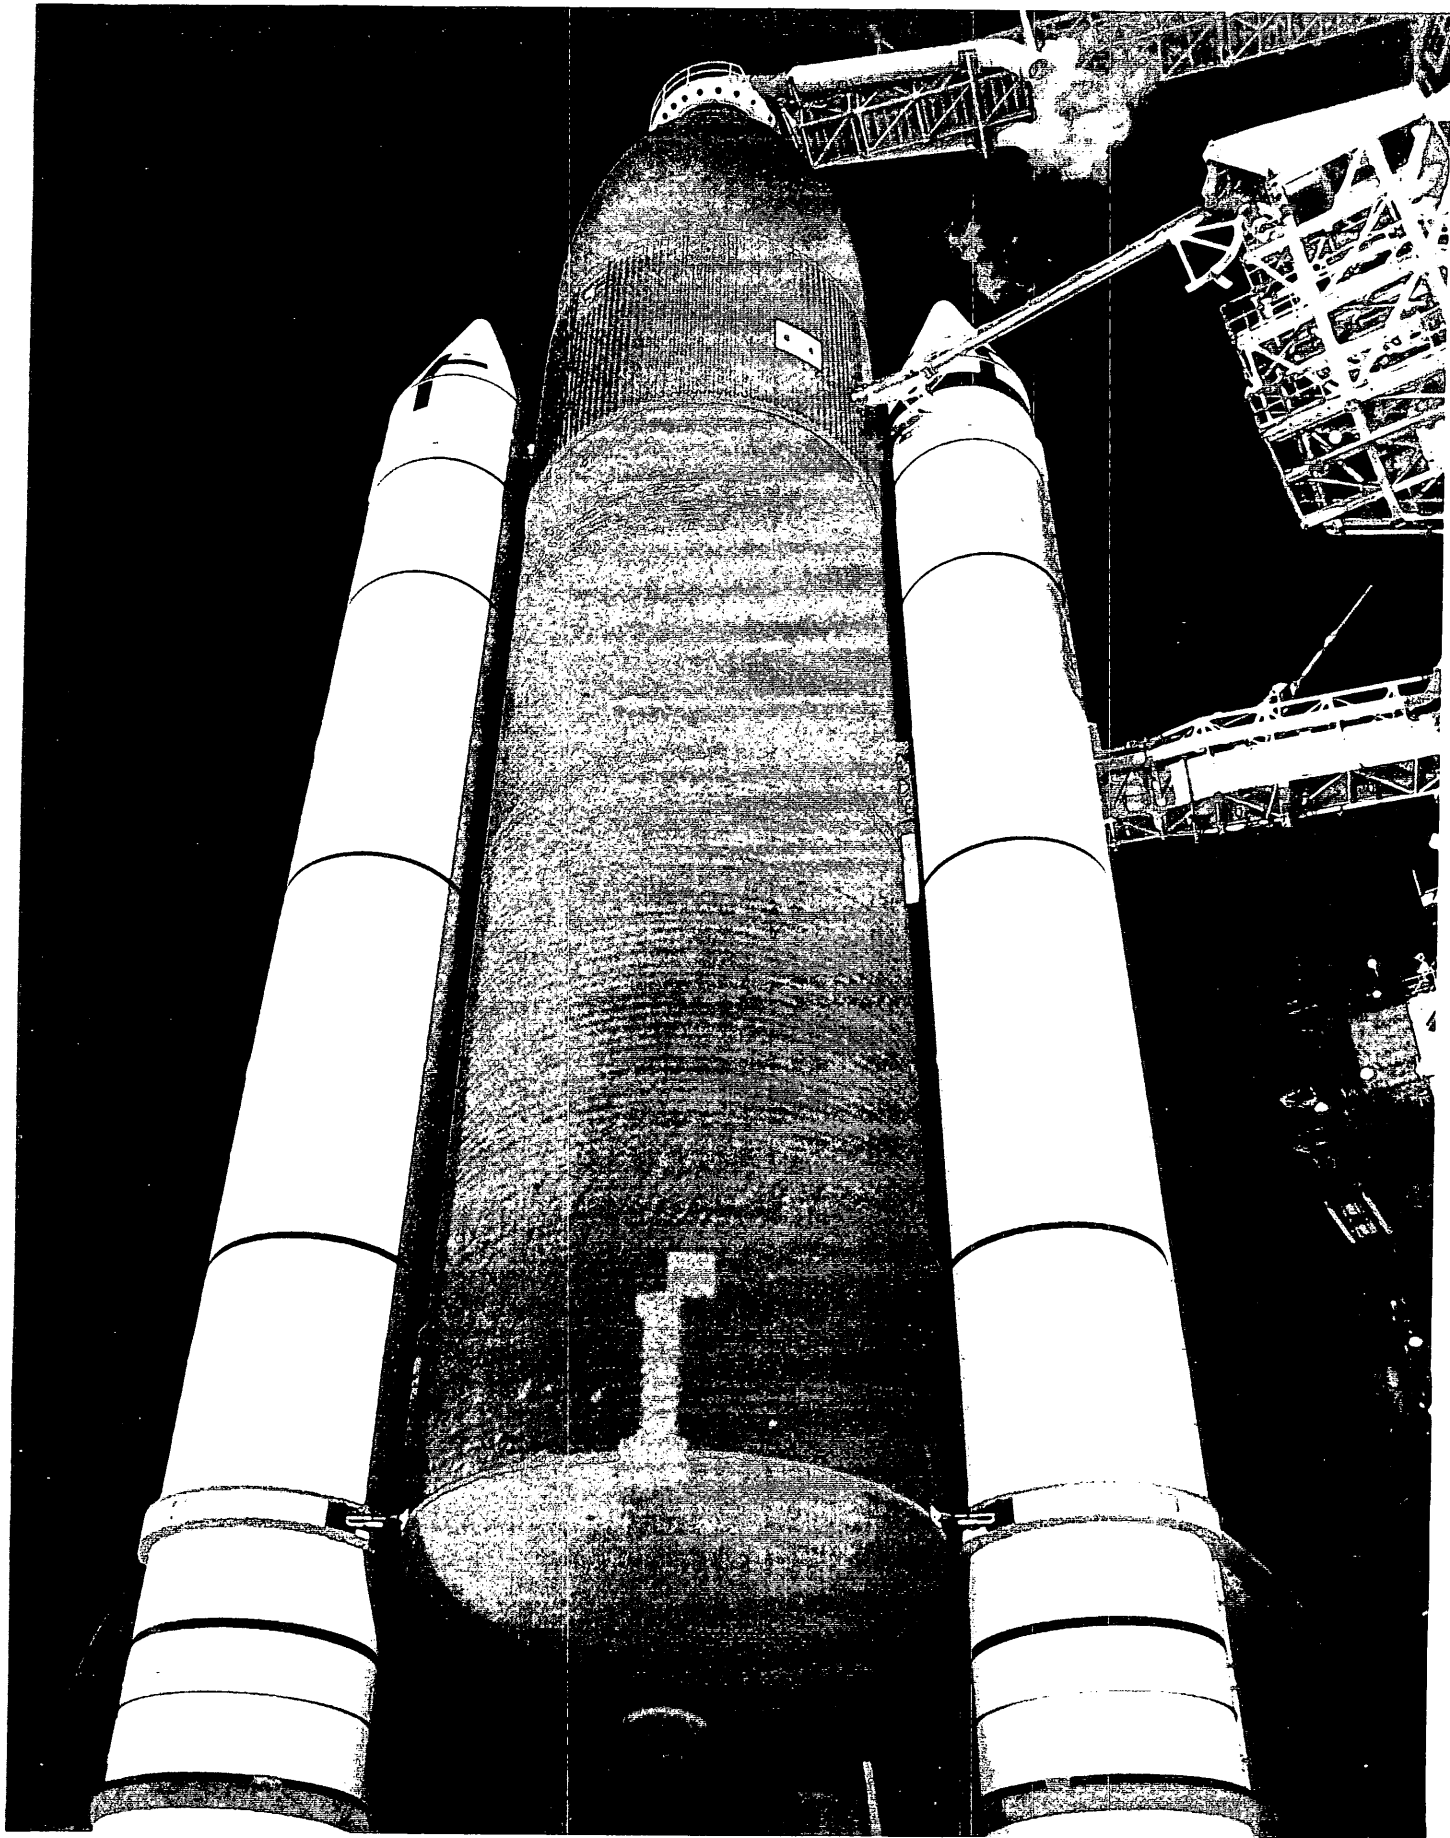
Overall view of ET-34 -Z side. There were no acreage TPS defects or anomalies
